| 1 2 3 4 5 6 7 8 9 10 11 12 13 14 | C. Brooks Cutter, SBN 121407 Wesley M. Griffith, SBN 286390 Jennifer S. Domer, SBN 305822 CUTTER LAW P.C. 401 Watt Avenue Sacramento, CA 95864 Telephone: (916) 290-9400 Facsimile: (916) 588-9330 E-mail: beutter@cutterlaw.com E-mail: wgriffith@cutterlaw.com E-mail: jdomer@cutterlaw.com Reza Torkzadeh, SBN 249550 Karen Johnson (pro hac vice to be filed) TORKLAW 18650 MacArthur Blvd., Ste 300 Irvine, CA 92612 Telephone: (916) 290-9400 Facsimile: (916) 588-9330 E-mail: reza@torklaw.com E-mail: karen@torklaw.com Attorneys for Plaintiffs UNITED STATES DISTRICT COURT NORTHERN DISTRICT OF CALIFORNIA | | | |

I. INTRODUCTION

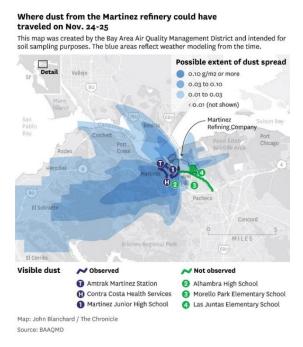
- 80. In total, approximately twenty-four thousand tons of toxic spent catalyst were released into the surrounding communities by PBF Martinez.
 - 81. Here is a map showing the approximate spread of the spent catalyst:

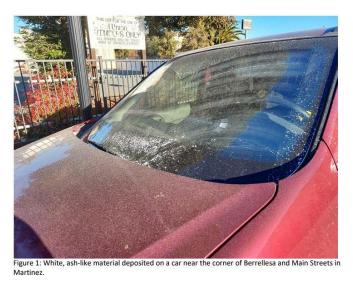
82. Here's an example of spent catalyst accumultaing on a car in Martinez:

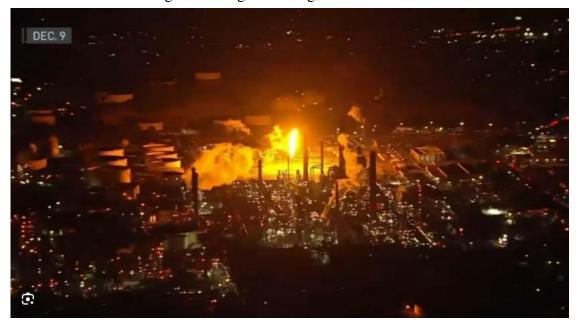
- 95. On December 9, 2022, the refinery experienced a larger than usual flaring event, which was unsettling to many people who live in the area.
 - 96. Here is an image reflecting the flaring:

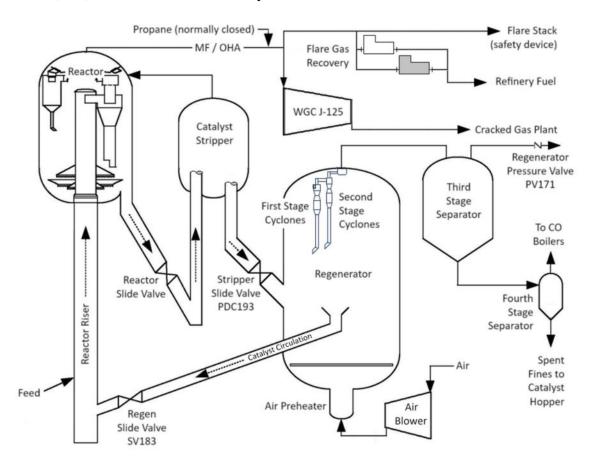
Figure 1: MRC's Catalytic Cracking Unit

Figure 1 provides an overview of the Catalyst Cracking Unit (CCU) process, the primary focus of this incident. Connected processes mentioned in the figure include the CO Boilers (COBs), the Cracked Gas Plant (CGP), and the Flare Gas Recovery Unit.

Catalytic cracking was developed and commercialized circa 1940. This technology increases the yield of high-quality products by reducing, or "cracking," larger complex hydrocarbon (HC) molecules⁴ into lighter products. Larger HC oils are heated and pumped into the Reactor Riser (RR) where they contact nearly 1300 °F powdered catalyst. In the RR, the larger HC molecules are cracked into smaller molecules such as gasoline, butane, or propane. This reaction also deposits carbon on the catalyst.

⁷ See process diagram in Figure 1.

| | Commenter Name | Organization | Comment | Page of Report | Section of Report | Scott Berger & Assoc. Response | Report Modifications Made |
|---|---|---|---|---|---|--|--|
| 57 | CCH Hazmat | ССН | Figure 1: Catalytic Cracking Unit, suggest adding MRC before Catalytic | Page 8 | | Thank you. | Done. See page 5 Figure 1 caption. |
| 60 | CCH Hazmat | ССН | Figure 1: Suggest labeling air compressor as air blower for report consistency | Page 8 | | Thank you. | Done. See page 5 figure 1. |

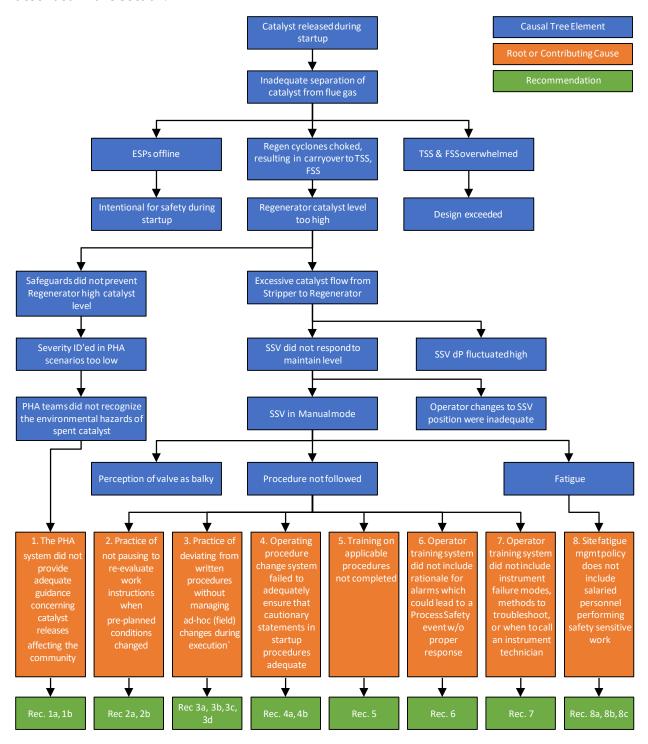
Figure 2: Causal tree of November 24-25, 2022, Catalyst Release Incident

The causal tree for this incident is shown below (Figure 2). The key links in the causal chain are described in this section.

Evaluation of PHA scenarios as "No Action Required": Long before this incident, two separate process hazards analyses (PHAs) had been conducted. Each considered causes that could lead to catalyst carryover: the Shell Oil Products CCU PHA in 2018, and the MRC/PBF CO Boilers PHA in 2022. Each PHA team identified scenarios with a potential for a severity two (2) environmental consequence (meaning, minor or no lasting environmental effect, a quantity of release requiring agency notification, or short duration remediation). After evaluating the 2022 catalyst release, CCHHMP determined that the event was a Community Warning System (CWS) Level 2 or higher MCAR due to the need to clean up the released catalyst. The Shell and MRC/PBF systems assign a consequence category of 3 if environmental cleanup is required.

| | Commenter Name | Organization | Comment | Page of Report | Section of Report | Scott Berger & Assoc. Response | Report Modifications Made |
|---|---|---|---|---|---|---|--|
| 62 | CCH Hazmat | ССН | General Comment, to be consistent with the presentation from 2/1/24 and as stated on the presentation slides, replace the word culture with practice from root causes in Figure 2 and update corresponding report language to clarify as necessary (including in tables). | Pages 11 and 12, 16-20, 23-24 | | Thank you. | Done. |
| 63 | CCH Hazmat | ССН | Figure 2, define PS | Page 11 | | Thank you. | Relabeled figure replacing PS with Process Safety. See page 11, Figure 2. |
